OAKLAND POLICE ADMINISTRATION BUILDING

SEISMIC RETROFIT EVALUATION FOR THE "911" FUNCTION

Prepared For
The City Of Oakland
Office of Public Works

August 20, 1993

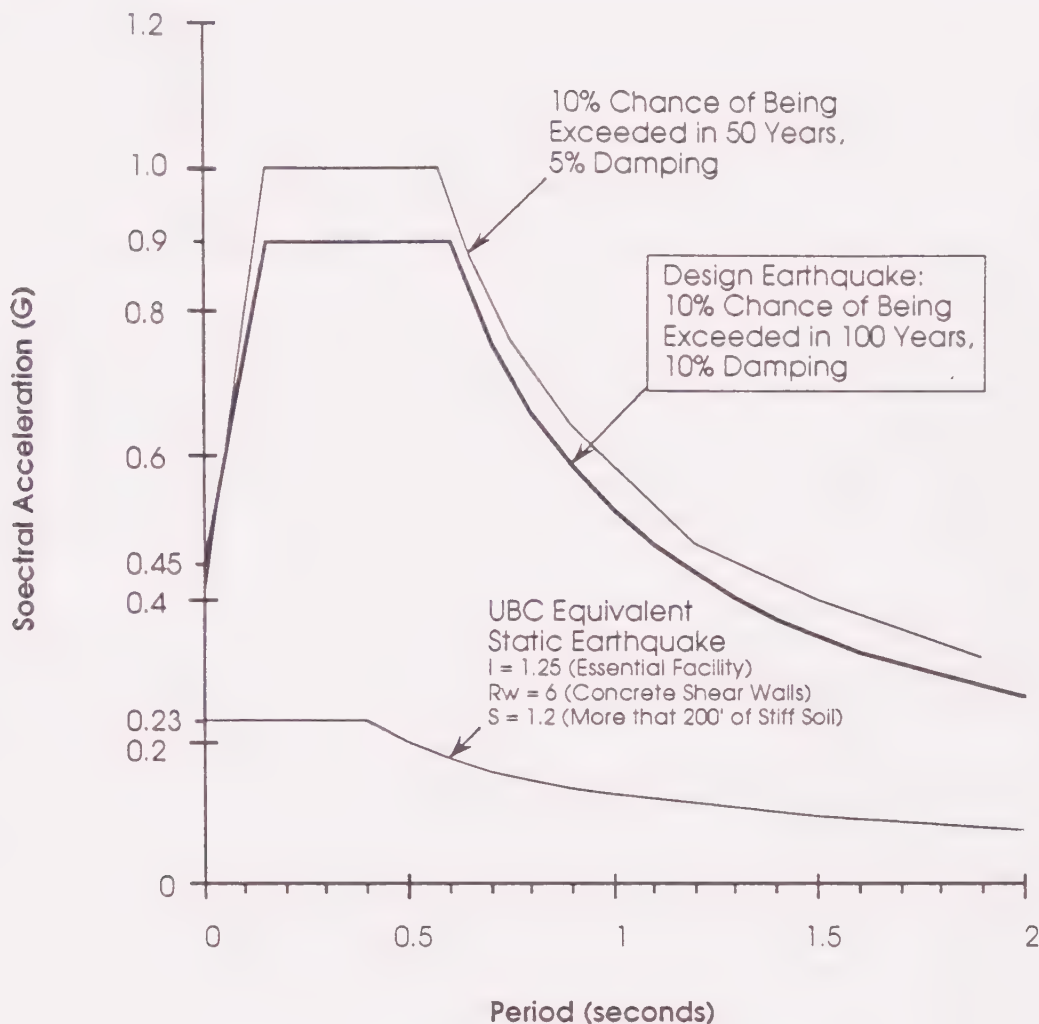
Figure B-1. Comparison of Earthquake Risk Levels

The unreduced UBC normalized response spectrum based on a PGA of 0.4g represents an earthquake with a 10% chance of being exceeded in 50 years. The UBC spectrum is also based on a 5% damping value which was judged inappropriate for assessing the realistic response of this building. It should be noted that the UBC spectrum actually represents a less severe event (i.e. a higher risk level) than that represented by the design

earthquake. A comparison of the different levels of earthquakes is shown graphically in Figure B-1.

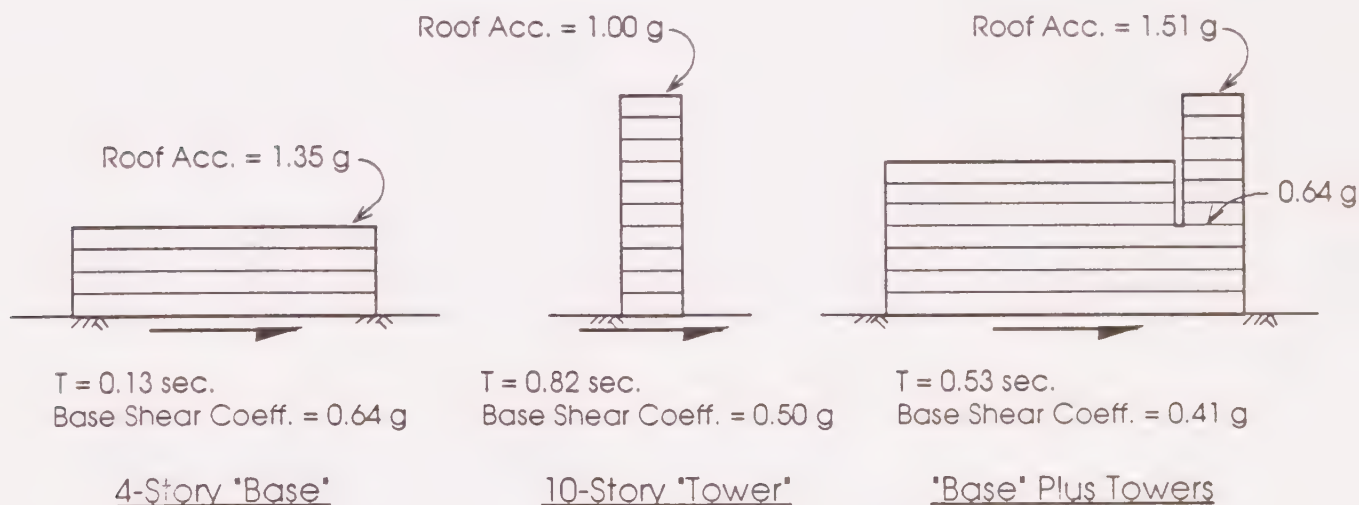
Figure B-4. Comparison of Base Shear Coefficients and Roof/Floor Accelerations

The base shears for the entire building are 15765 k and 15559 k for the east-west and north-south directions, respectively. The base shears for the bottom four floors only are 14342 k and 15774 k for the east-west and north-south directions, respectively. Comparison of these base shears and the 4th floor accelerations indicates that the six Tower floors and three Courthouse floors above do not increase the base shear of the bottom floors proportionately to their added mass, however, they do significantly change the distribution of story forces - in general, the seismic forces attenuate up the Tower and Courthouse. See Figure B-4 for a comparison of base shear coefficients and roof/floor accelerations.
